# AIRCRAFT SERIOUS INCIDENT FINAL REPORT

SI 01/23P

**Piper Archer III PA28-181, Registration 9M-SKJ  
at an Open Construction Area in Jasin, Malacca  
on the 14 February 2023**

**ACCIDENT REPORT NO.: SI 01/23**

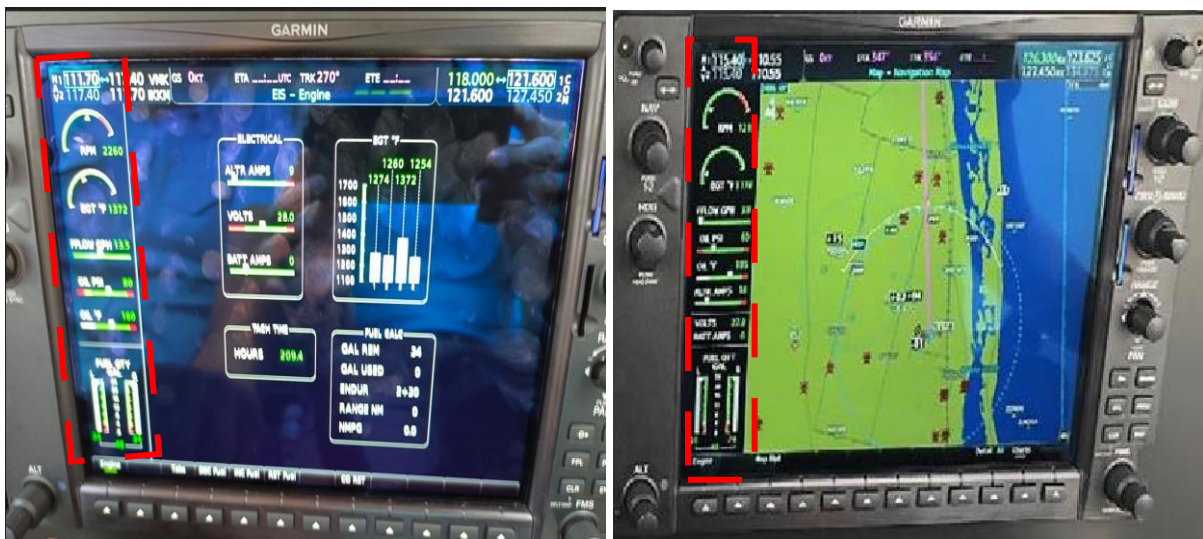
Figure 19: Engine Indicating System Page on Multi-Function Display

The MFD also incorporates a dedicated Engine Indicating System (EIS) page along the left side of the MFD window that displays engine parameters, electrical system parameters, and fuel quantity as shown in Figure 19.

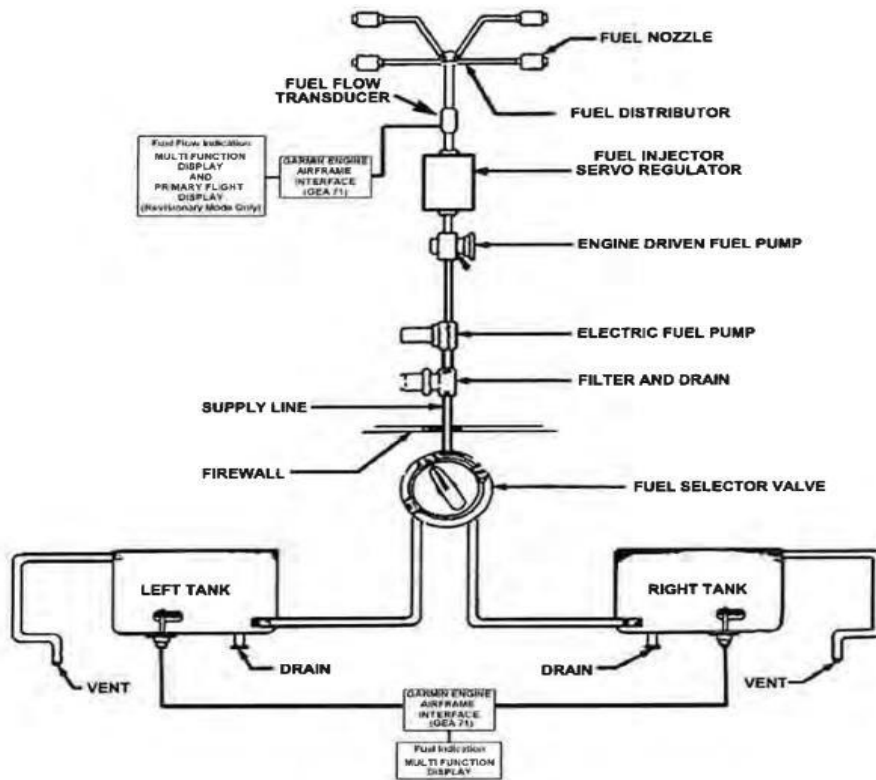
Figure 20: Fuel System Schematic – Fuel Injection Engine

Based on the Fuel System Schematic at Figure 20, the FIS regulates meter fuel flow proportionally with airflow and maintains the mixture for all engine speeds. The fuel flow divider receives metered fuel and distributes fuel to each cylinder fuel nozzle. Based on the EIS data recording (Figure 21), the fuel flow remains consistent with the power output.
