# AIRCRAFT ACCIDENT REPORT 03/15

## Air Accident Investigation Bureau

Report on the accident to Helicopter Dauphine,  
AS 365 N3 Registration 9M-IGB near Subang Airport,  
40 Nautical Miles Sout East of Subang Airport,  
MALAYSIA  
(N 03 00.64 E101 51.19)

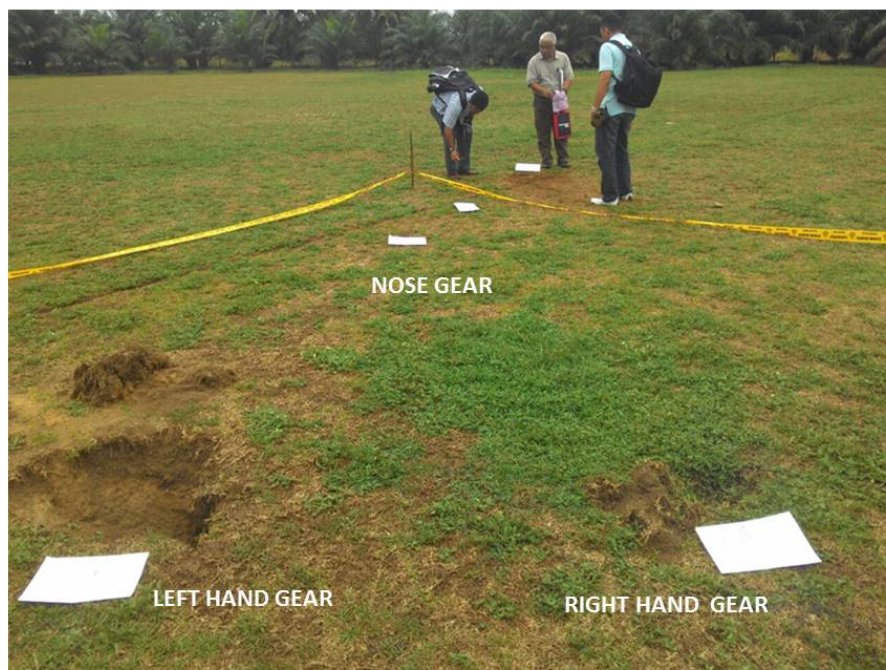
Fig 9

The helicopter made an unscheduled landing at SKLBK. While landing at the school field, the Left Hand (LH) Landing Gear sunk into the ground. The photo below shows the sunk hole on the ground due to the landing gear.

The traces of fluid from the sunken hole was collected and sent to the Chemist Department of Malaysia for detailed analysis. The sample fluid was traced to meet the Mobil Jet Oil II (Synthetic) specification. See figure 11.

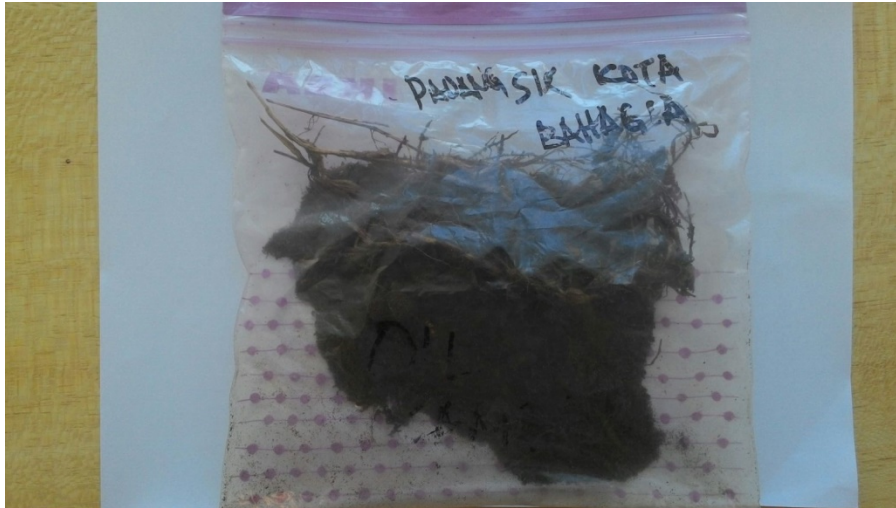
Fig. 11

The traces of earth with oil sample was placed in a plastic bag and sent to Chemist Department of Malaysia for detailed analysis. See Fig. 11.

Test result from the Chemistry Department of Malaysia shows that the sample taken at the SK Ladang Kota Bahagia is consistent with the Mobil Jet Oil II (Synthetic) of the AS365N3 helicopter hydraulic fluid specification.

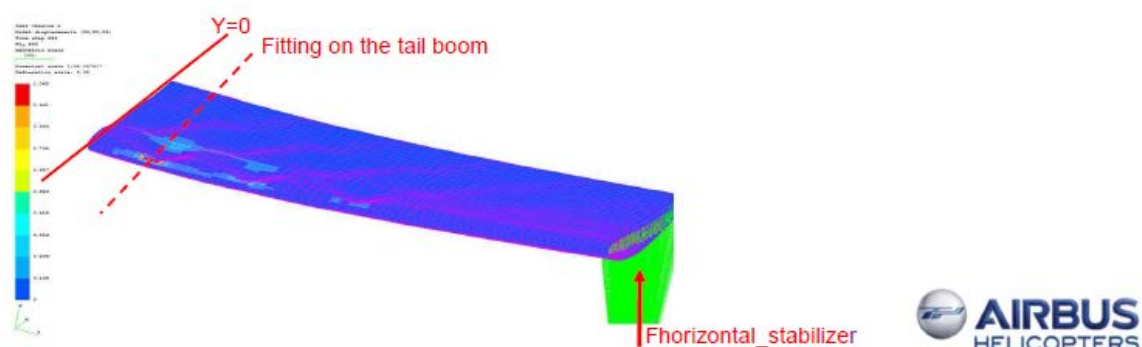
Fig.27

- The horizontal stabilizer begins to damage for a vertical load at its extremity of 160daN.  
( $\ll$  Fleft\_mlg = 1874 daN when outboard tail fin contacts the ground)
- Under  $F_z=160\text{daN}$  the horizontal stabilizer bent of 45mm.  
( $\ll$  237mm when the Left landing gear is in the soil of 40cm)

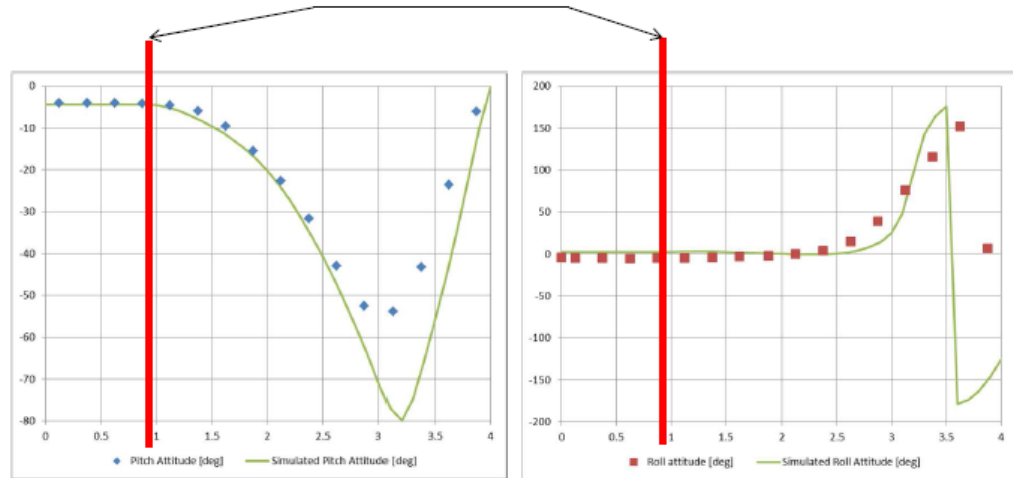
Suspected Loss of the left  
horizontal stabilizer

***Nota:*** Once the vertical load factor  $-1g$  is reached the simulation can differ from the real flight as the aircraft is completely outside of the certified flight envelope

The observed result of the simulation is consistent with the FDR

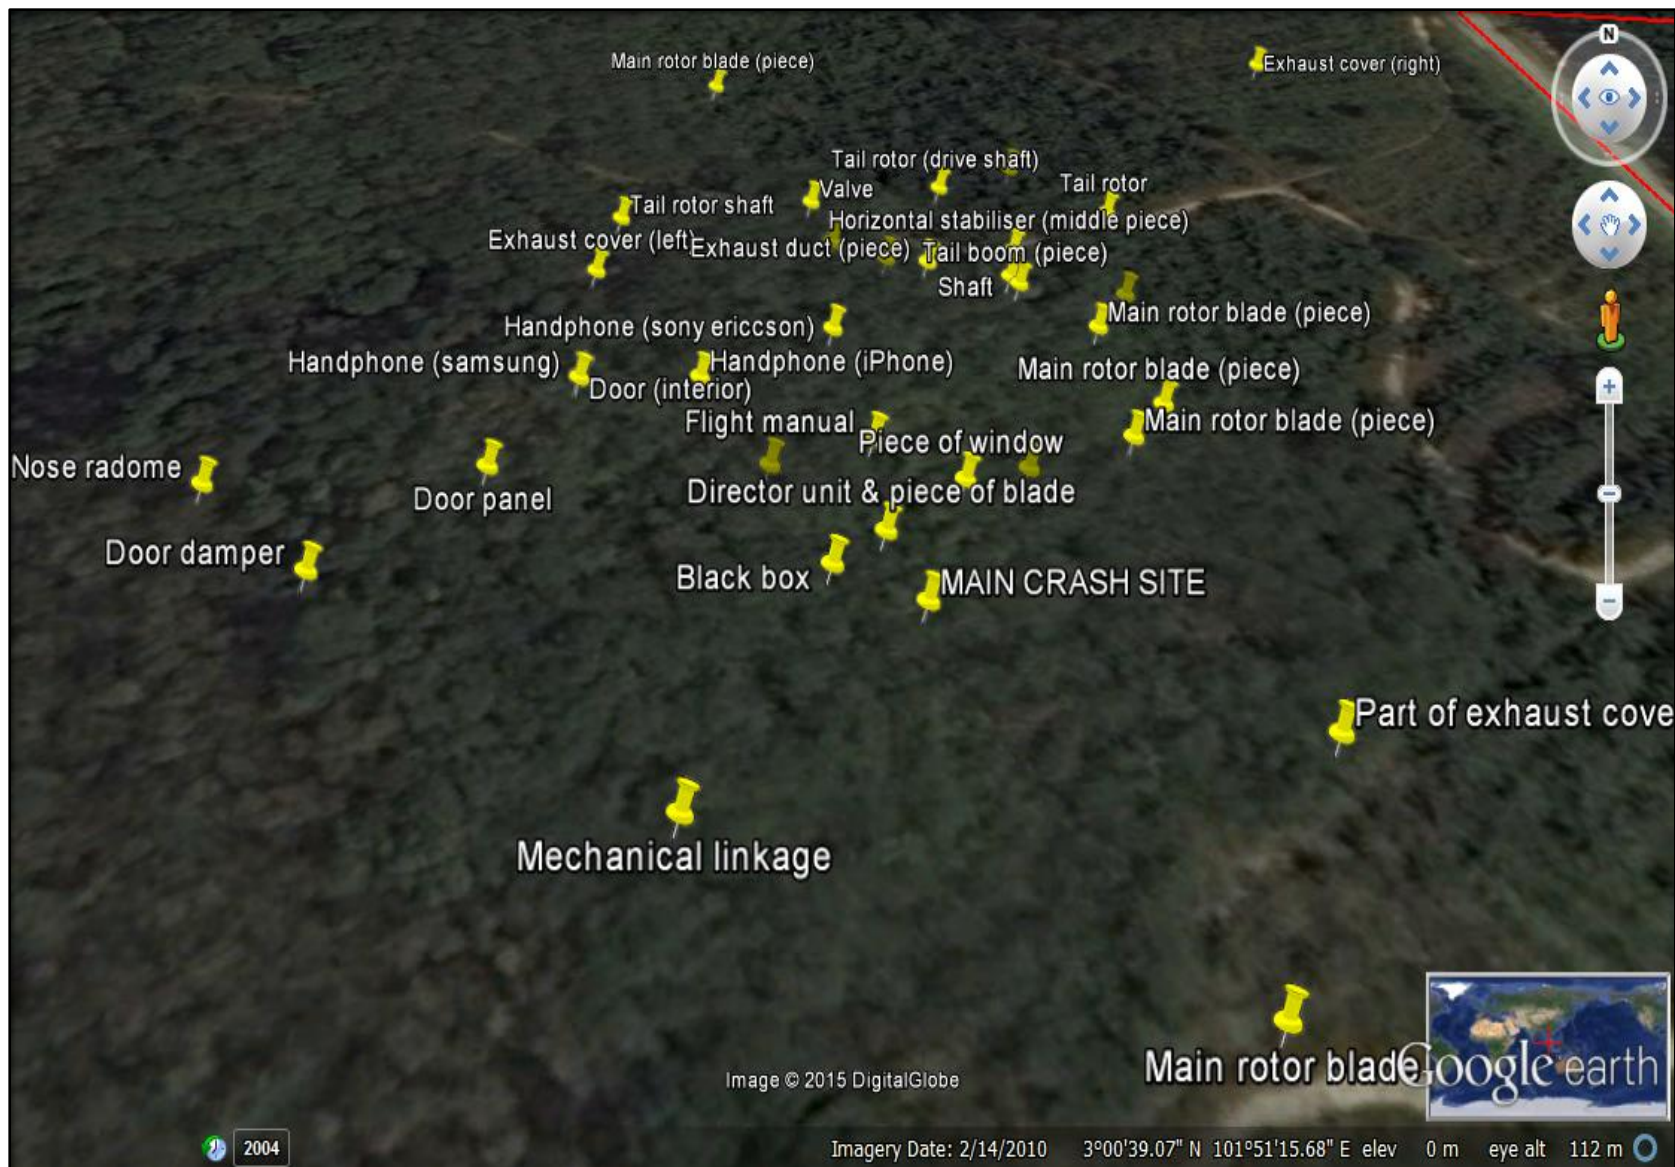
# WRECKAGE DISTRIBUTION

The aircraft wreckage was significantly damaged by the impact forces and the post-crash fire at the bottom of a ravine. Many of the aircraft parts including MGB and engine cowling, engine exhaust pipe, main rotor head and blades, entire fenestron, main landing gears and fuselage doors were collected from a distance of about 300 metres from the main wreckage along the steep slope of the hills. The parts recovered were on the suspected trajectory of the route flown. No evidence of aircraft contact with the terrain until the vertical impact of the main wreckage. All the parts recovered have been made available for examination in a hangar. The helicopter was destroyed due to high impact and consumed by post crash fire. (See wreckage distribution at Appendix 4)

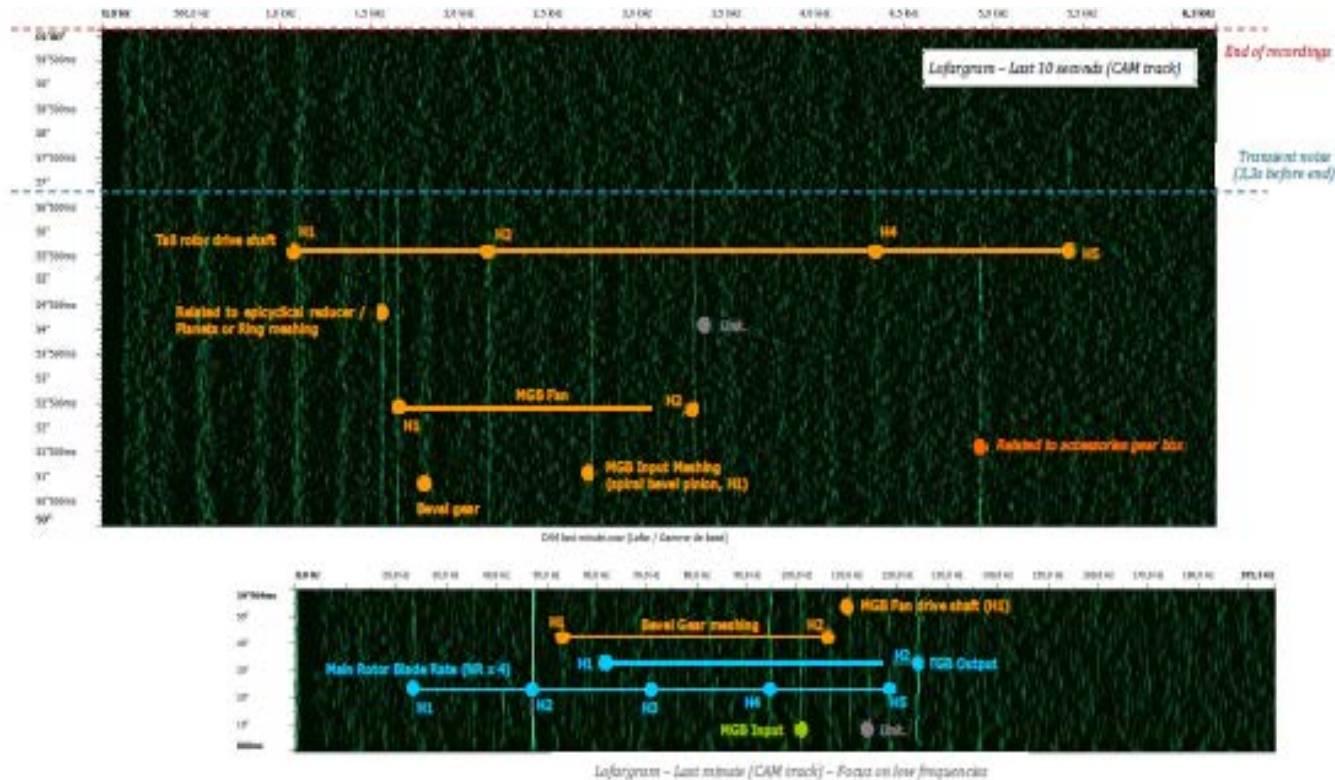
## 9M-IGB-PROPULSION SYSTEM CONDITION (LAST MINUTE OF RECORDING)-SPECTRUM OVERVIEW

The audio files *CAM last minute.wav*, *Ch1 last minute.wav* and *Ch2 last minute .wav* contain the last minute of respectively CAM, Channel 1 and channel 2 recordings. The spectrum view in Appendix 8, Fig 3 showed several acoustic signatures (harmonic families) typical of the helicopter propulsion system spectrum:

These fundamental frequency values indicate that the propulsion system was at 100% of its nominal rate (confirmed by FDR data, see Appendix 8, Fig 1). The propulsion system condition appeared to be nominal until 3.3 seconds before the end of recordings. At that moment, a transient noise was recorded on the CVR. It was not possible to determine the nature and the origin of that noise. 0.5 seconds after that noise (i.e. 2.8 s before end of recordings), the spectral lines associated with the helicopter propulsion system disappeared. This disappearance coincided with the appearance of a high energy level phenomenon. That phenomenon was made up of multiple acoustic events similar to impact noises (see Appendix 8, Fig 2). Several warnings were triggered during that phenomenon. The interval between each impact is a multiple of the main rotor shaft rate, which allows asserting that the impacts recorded are main rotor blades collision with an external unknown item. The measure of impacts intervals at the *High NR* warning triggering indicated that the main rotor speed was 8% (i.e. 108.4 %) above its nominal speed rate, which was consistent with FDR data. However, the limitation of acoustic analysis made it impossible to describe the impacts sequence. Other

This acoustic signature was consistent with nominal acoustic signature normally observed on A6365 family helicopter. The propulsion system condition appeared to be nominal until 3.4 seconds before the end of recordings. At this moment, a transient noise was recorded on the CVR. 0.5 seconds after this noise (i.e. 2.8 s before the end of the audio recordings), the spectral lines associated with the helicopter propulsion system disappeared. This disappearance was simultaneous with the appearance of a high energy level phenomenon. Considering the wide band noise generated by this phenomenon, it was not possible to describe the behavior of spectral lines associated with the helicopter propulsion system.

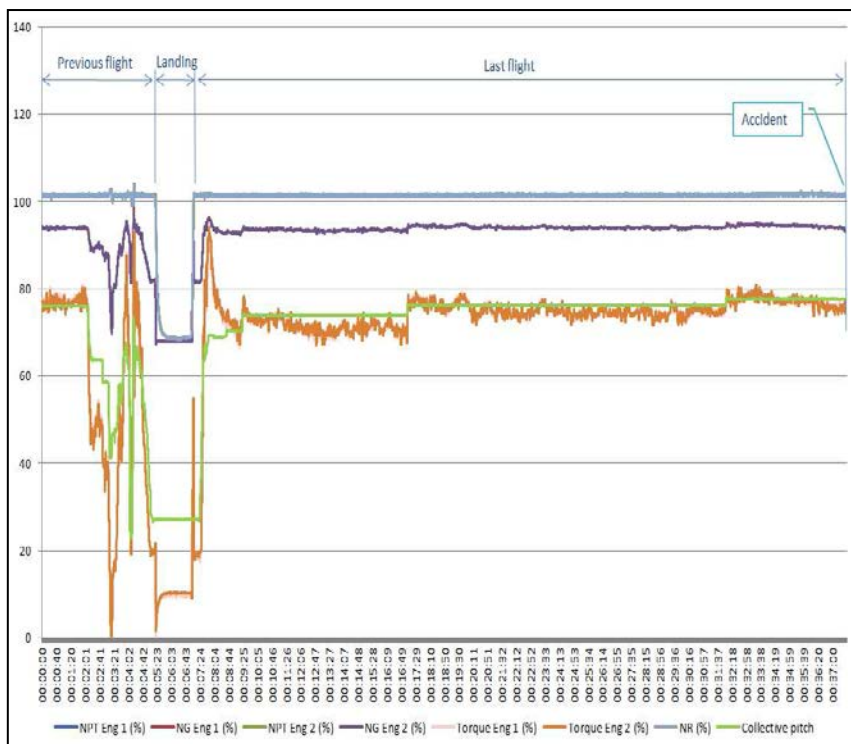
LANDING AT OPEN FIELD AT 08.20  
 BANK 13\*36"AND LH WHEEL SUNK 20 INCHES DEPTH  
 HELICOPTER REMAIN ON GROUND FOR 3 MIN. AND TAKE OFF AT 08.24

This landing was carried out on loose soil, with the LH main landing gear sinking into the ground by 50 cm. This led to significant roll to the left (13°) and to the contact between the side fin and the ground, which caused severe damage to the horizontal stabilizer at the junction where it crosses the tail boom. In addition, a hydraulic fluid leakage had been observed by the pilot but no inspection was carried out on the helicopter before the subsequent take-off.

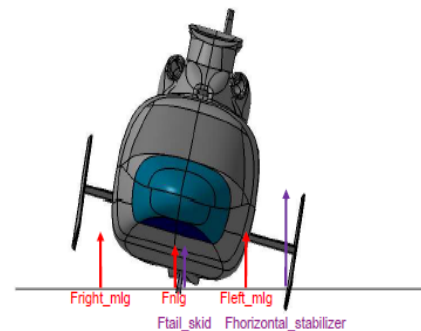
Outboard fin Ground clearance

Static equilibrium + Left landing gear in the soil of 38cm
