AIRCRAFT ACCIDENT FINAL REPORT
A 03/22P
Air Accident Investigation Bureau (AAIB)
Ministry of Transport Malaysia

Piper Warrior II PA28-161, Registration 9M-BAA
beside Sungai Pinji, near Medan Gopeng, Ipoh, Perak
on the 01 August 2022

ACCIDENT REPORT NO.: A 03/22

OPERATOR : BATS AVIATION SDN BHD
AIRCRAFT TYPE : PIPER WARRIOR II PA28-161
NATIONALITY OF AIRCRAFT : MALAYSIA
REGISTRATION : 9M-BAA
**PLACE OF OCCURRENCE : BESIDE SUNGAI PINJI, NEAR MEDAN
GOPENG, IPOH, PERAK**
DATE AND TIME : 01 AUGUST 2022 AT 2007 LT

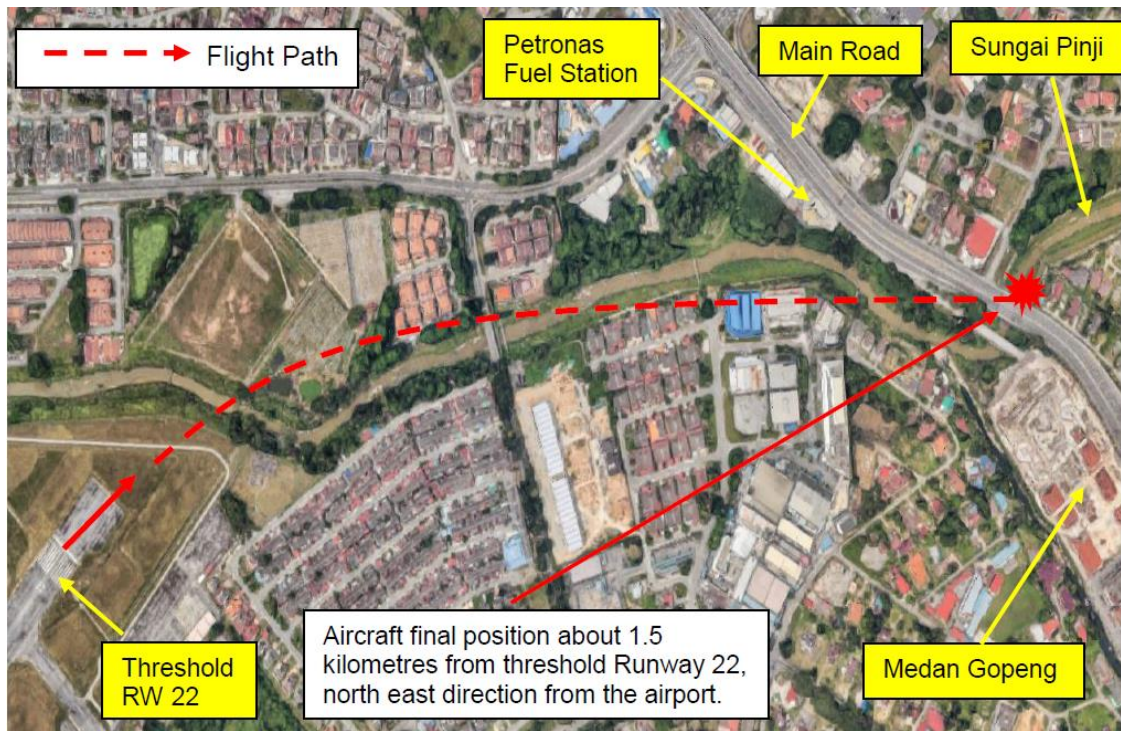
Figure 16: Flight path and final position of aircraft (Diagram not to scale)

The aircraft's right wing hit a lamp post situated on a road bridge and the wing broke into two. It then veered right and rotated 180° slamming into the side of the water diversion culvert, aircraft belly first before coming to a rest with the aircraft nose facing vertically down. The aircraft suffered major damage to the right side, undercarriage, engine nacelle lower section and rear T-tail plane.

Photo 6 & 7 – The aircraft's right wing impacted the lamp post and rotated clockwise 180° nose down pivoting on the lamp post and swung across the water diversion culvert, belly first. When the aircraft swung across the culvert, it missed hitting an electrical pole as the right wing had sheared off from the aircraft main fuselage.

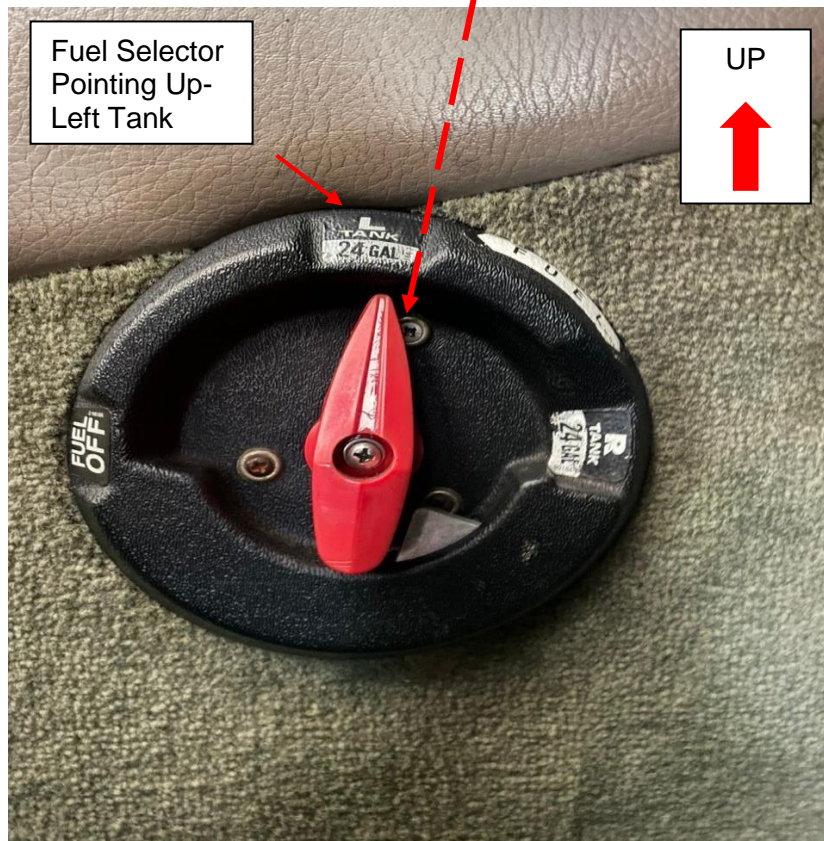
Figure 23: Fuel Selector Position on a Normal Aircraft

Evidence at the aircraft wreckage shows that the Magneto Switch was at 'L' (Left) position and the Carburettor Heat Lever at 'ON' position. The Fuel Selector was selected to Left Tank. The Throttle Lever was at 'CLOSED' and Mixture Lever was at 'IDLE CUT-OFF' position. One propeller had bend inwards after impacting the lamp post while the other blade was in normal condition with some scratch marks. Flaps were observed to be at UP position (Figure 18 to 23).

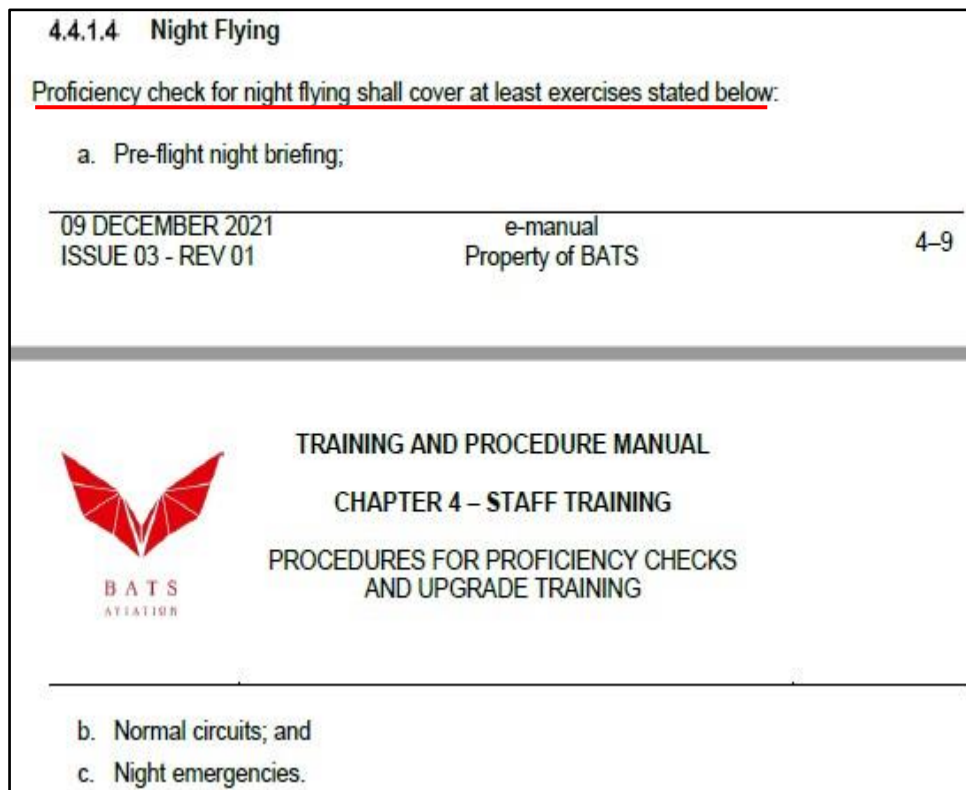
Figure 26: BATS Training and Procedure Manual – Night Flying

The Training and Procedure Manual (TPM) states that night flying currency check shall cover at least the exercises stated in Figure 26⁴. A more specific directive is needed to include ground operations which covers start-up, engine ground check, taxi and shutdown since night flying training is flying syllabus dependent and not regularly carried out at the FTOs.

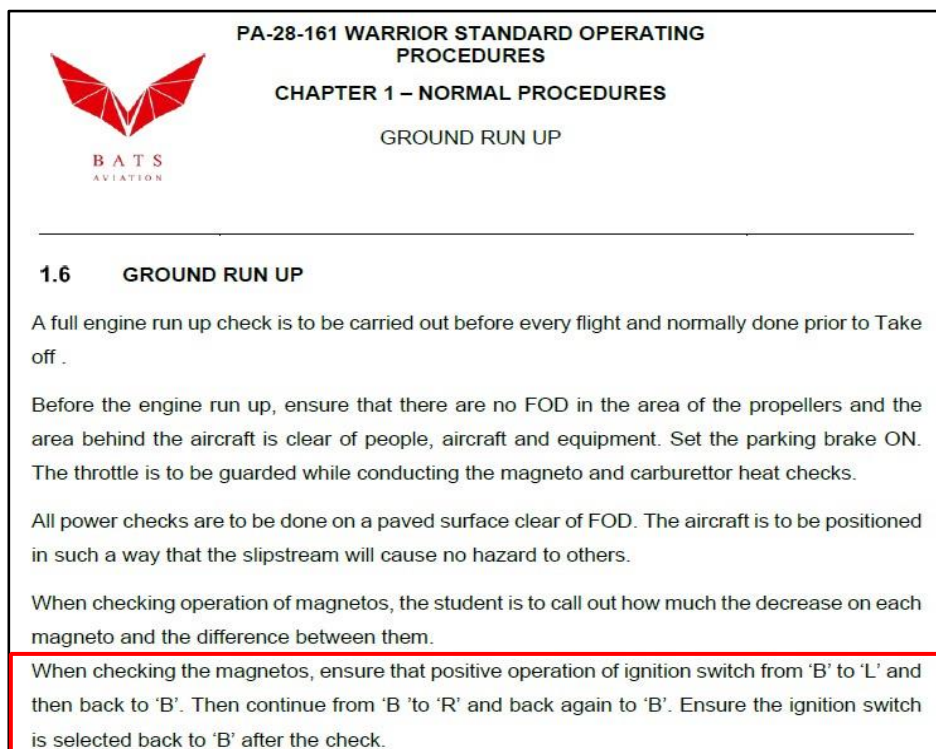
Figure 28: Standard Operating Procedures – Ground Run Up

The PA28-161 Warrior Standard Operating Procedures (SOP) also provides clear guidelines on the correct procedure to carry out an engine ground check especially with regards to performing magneto operations check (Figure 28).

Pilot 2 started and performed the engine ground check alone despite not current on NF. Pilot 2 interview statement states that the engine ground check was monitored by Pilot 1 after Pilot 1 boarded the aircraft. Nevertheless, CCTV recording shows that Pilot 2 actually performed the engine ground check before Pilot 1 boarded the aircraft. The marshaller can be clearly seen giving the engine ground check hand signal to the Pilot 2 after the aircraft engine was started. The engine ground check was carried out before Pilot 1 aircraft had landed. Interview statement from the Maintenance Manager who was also the marshaller on duty that night confirms the above actions.

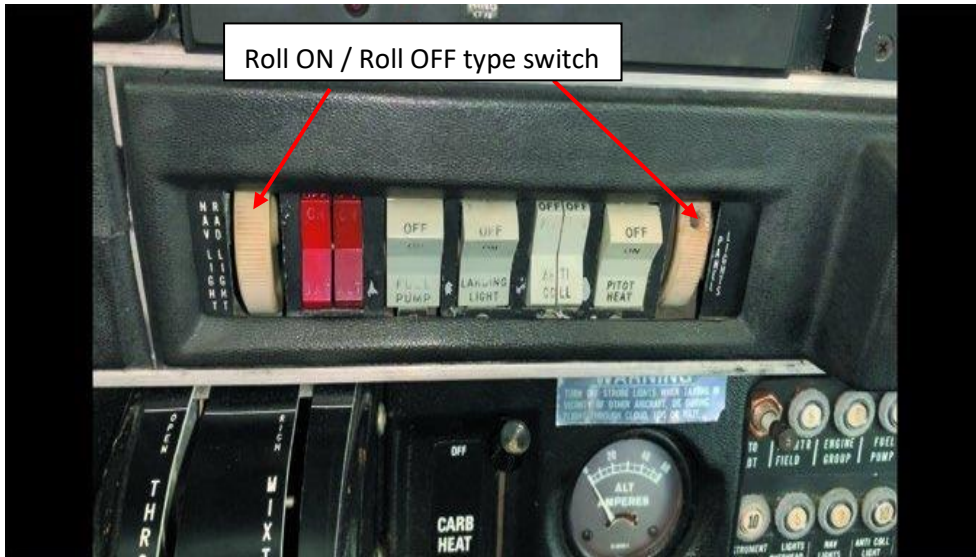
Pilot 2 and Pilot 5 interview statement revealed that the aircraft (9M-BAA – Warrior II) instrument lights were dimmer than normal as compared to another similar aircraft. There was no evidence on any defect raised on the instrument's lights by any pilots. The Warrior II aircraft does not have a variable instrument lighting intensity control switch like in the Warrior III aircraft which allows the pilot to control the brightness for instrument reading clarity. The light switch in the Warrior II aircraft is a roll ON and roll OFF type switch as in Figure 32.
