**AIRCRAFT ACCIDENT FINAL REPORT NUMBER A05/2016**

**ACCIDENT INVOLVING EUROCOPTER AS350 B3e REGISTRATION RP-C6828  
AT BATANG LUPAR, SARAWAK  
05 MAY 2016**

**ACCIDENT REPORT NO.: A05/2016**

**REGISTRATION : RP-C6828**

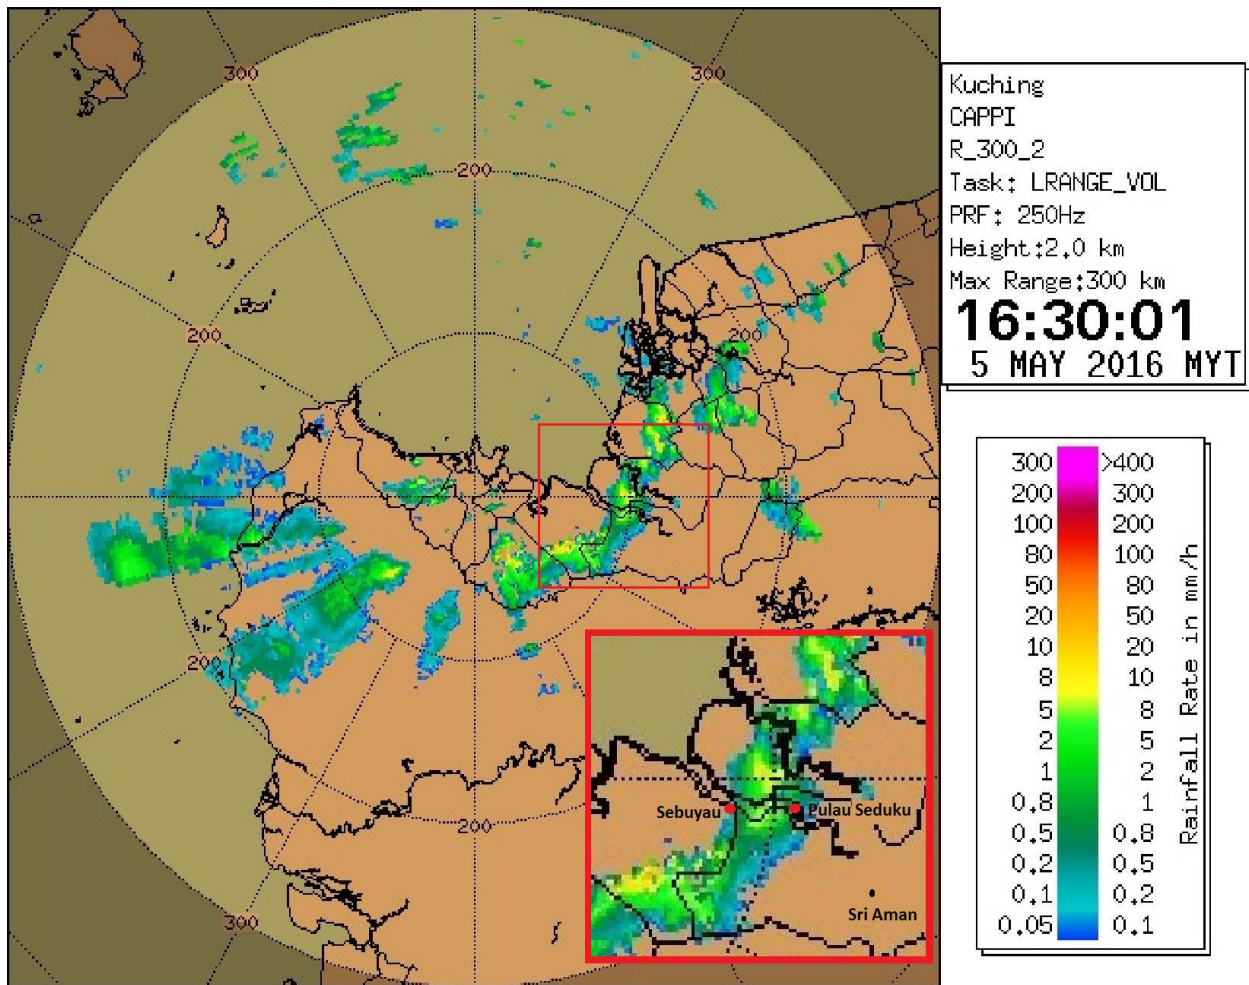
**Figure 2** Meteorological radar image at 1630 LT 5 May 2016

1.7.1.2 Meteorological radar image that was taken at 1630 LT on 5 May 2016 (Figure 2) showed that there was moderate rainfall of 5 to 10 millimetres per hour at the point

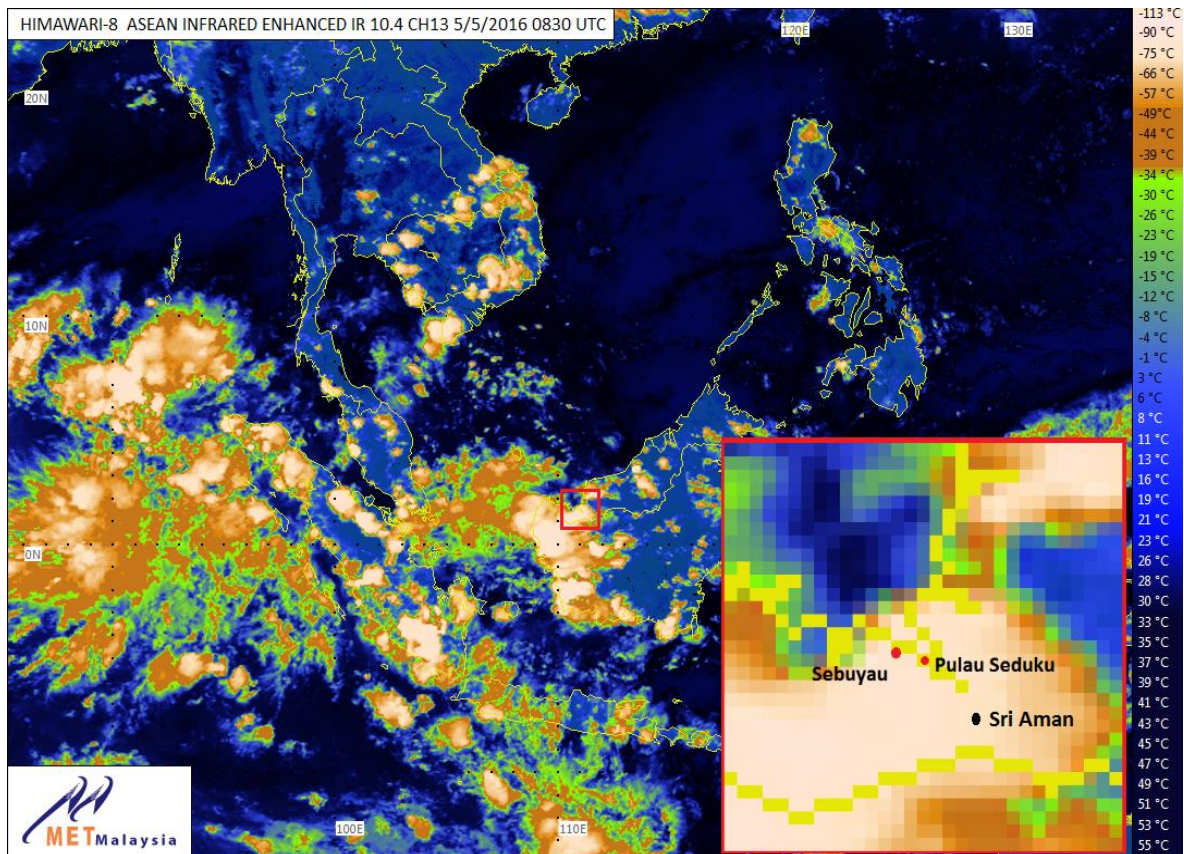
**Figure 3** Infrared satellite image taken by Himawari-8 at 1630 LT, 05 May 2016.

Infra-red images that were taken by the meteorological geostationary satellite Himawari-8 ASEAN INFRARED ENHANCED IR of Japan Meteorological Agency (JMA) at 1630 LT on the 5 May 2016 (*Figure 2*) showed that there were significant cumulus nimbus clouds developed from convective activities at the point of accident at 1630 LT.

1.7.2 The cloud image indicated that the cumulonimbus has reached mature stage. Thunderstorms contain many significant hazards to aviation especially for light aircraft flying at low levels such as the following:

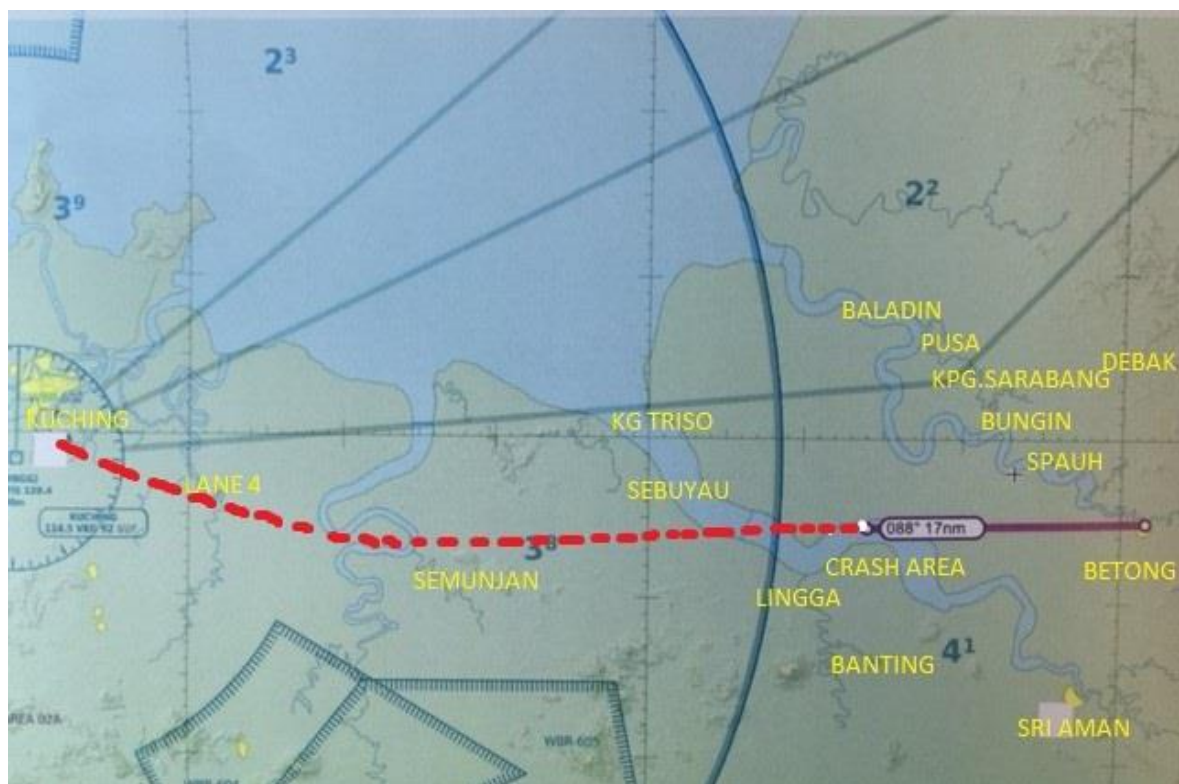
**Figure 4** The places surrounding the route of RP C6828 (in relation to Para 1.7.5)

1.7.5.5 9M-AZK took off Betong at 1625 LT for Kuching, claimed that the weather en-route to Kuching was bad with dark clouds and heavy rain. The helicopter deviated to the left of track over the mainland to maintain VMC.

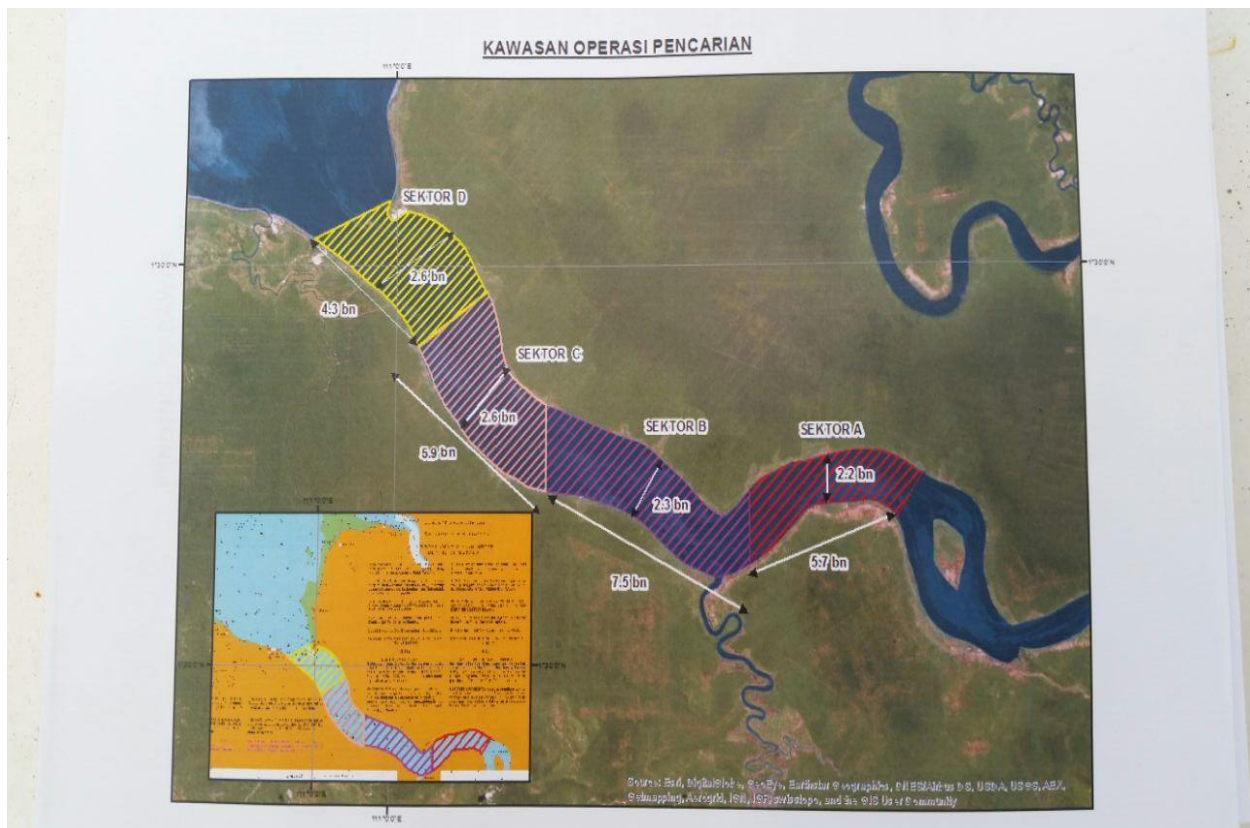
**Figure 7 : Search areas divided into sectors.**

1.15.2 After six (6) full days of scanning the Batang Lupar riverbed, the main wreckage was still not found. With reference to Sector A of Figure 7, the area was thoroughly scanned except for some areas which are too shallow even at high tide. These areas were less than two meters deep and it was assumed that any wreckage would protrude above the surface and be visible. Royal Malaysian Navy personnel scanned the highly probable areas adjacent to Sector A but their efforts were unsuccessful.

1.15.3 Following the completion of the search and recovery of Sector A, Sector B and subsequently Sector C were covered. Sector B was done from 12 July 2016 to 2 August 2016 and Sector C was carried out from 22 August 2016 to 26 August 2016. In the search and recovery of these two areas, the main aircraft wreckage was unable to be located.

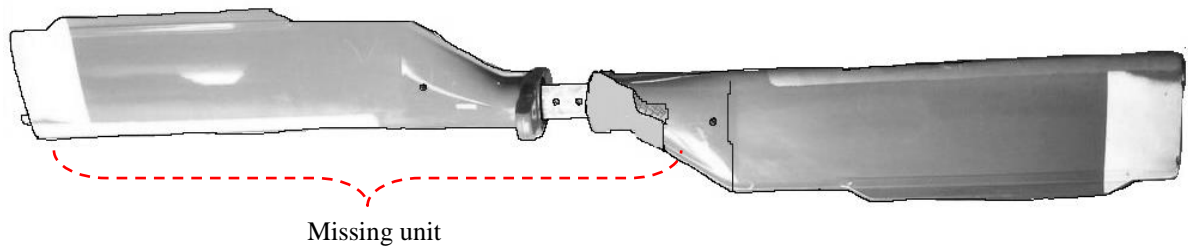
**Figure 10** : Tail rotor blade unit

Figure 10 shows illustration of the complete section of the tail rotor blade. The

examination was done in one section of the tail rotor blade while the other separated blade was missing.

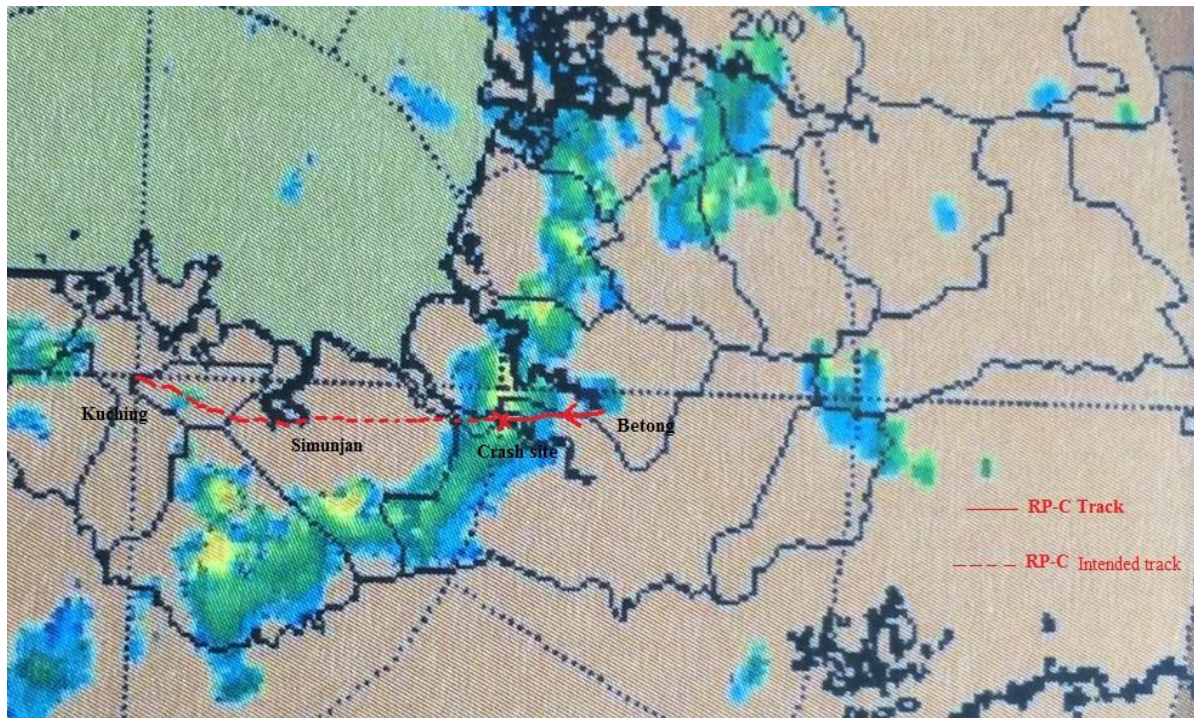
**Figure 21** : Satellite weather at 1630 LT on the 5th May 2016

5 helicopters (9M-WSE 9M -WSA, 9M-WSM 9M-AWB and 9M-AZK) that were flying in the same area at about the same time reported heavy rain with strong winds over Lingga area.

Based on the forecast and actual weather investigation believed that the flight has penetrated the rain and flying over the river at Lingga area.

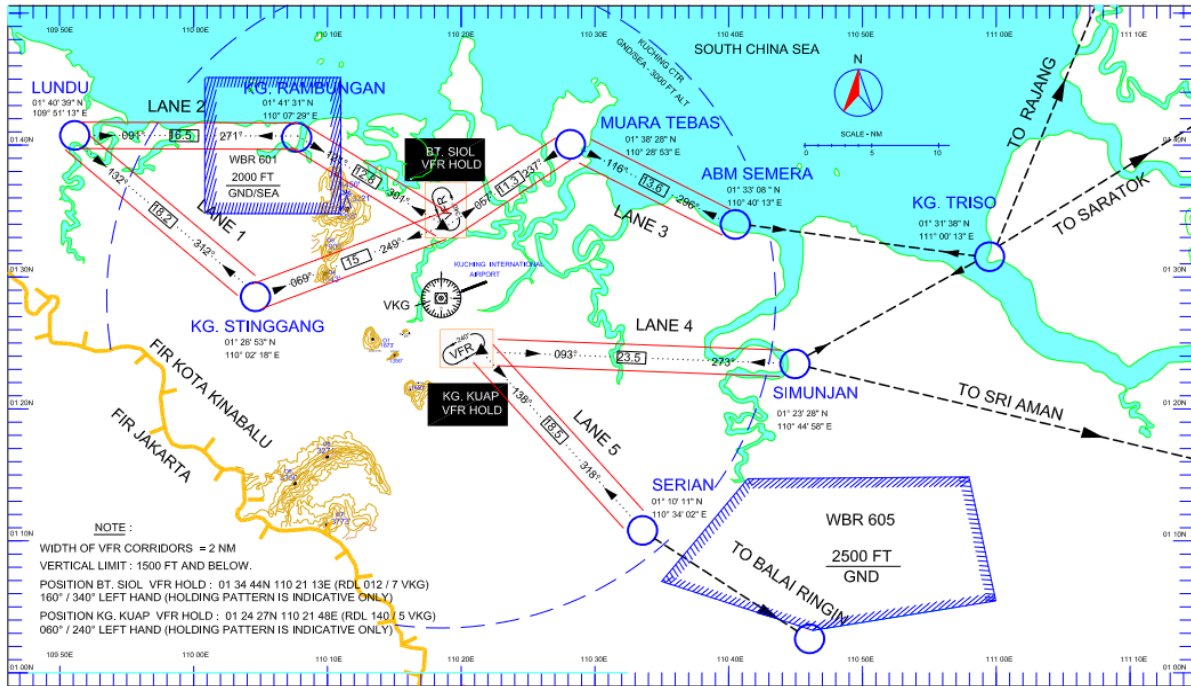
Figure 22a : VFR routes and VFR holding areas

The required route by Air Information Publication on VFR routes from Betong to Kuching is via Simunjan. Since the pilot was not familiar with the terrain and the severity of the weather during the flight, he could have navigated using the GPS information for the direct route to Simunjan which was the reporting point for VFR flight to enter Kuching control through VFR lane 4. However, before he could reach Simunjan at 1620LT, the weather surrounding Lingga, based on the satellite picture was covered with squalls and thunderstorm. He could have flown into the rain directly to Simunjan. See figure 22a and 22 b.
