AIRCRAFT SERIOUS INCIDENT

PRELIMINARY REPORT

SI 09/25

Fixed Wing Aircraft Boeing 737-800, Registration 9M-MXR

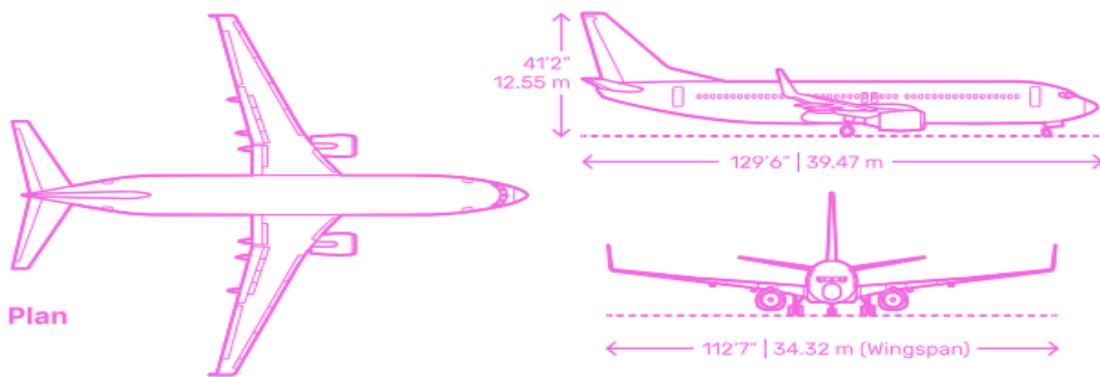
1.6.1 The Boeing 737-800 Next Generation (NG) aircraft in Malaysia Airlines Berhad (MAB) fleet features a standard wingspan for the type, design features a wingspan of 34.32 meters (augmented by advanced winglets to significantly reduce drag), and an overall length of 39.50 meters for maximum operational efficiency. Power is provided by two dependable CFM56-7B turbofan engines, each producing 117 kN of thrust. These capabilities enable the aircraft to cruise efficiently at Mach 0.79 (460 knots), operate with a high service ceiling of 41,000 feet, and achieve a substantial maximum range of up to 2,000 nautical miles.

Figure 3: Three views of the aircraft
