DEBRIS EXAMINATION REPORT

**Malaysia Airlines MH370 Boeing B777-200ER (9M-MRO)
08 March 2014**

Identification of Debris (Item 25 in the “Summary of Possible MH370 Debris Recovered”) recovered from Riake beach, Nosy Boraha Island, Madagascar in July 2016

Ref: DB/14/17

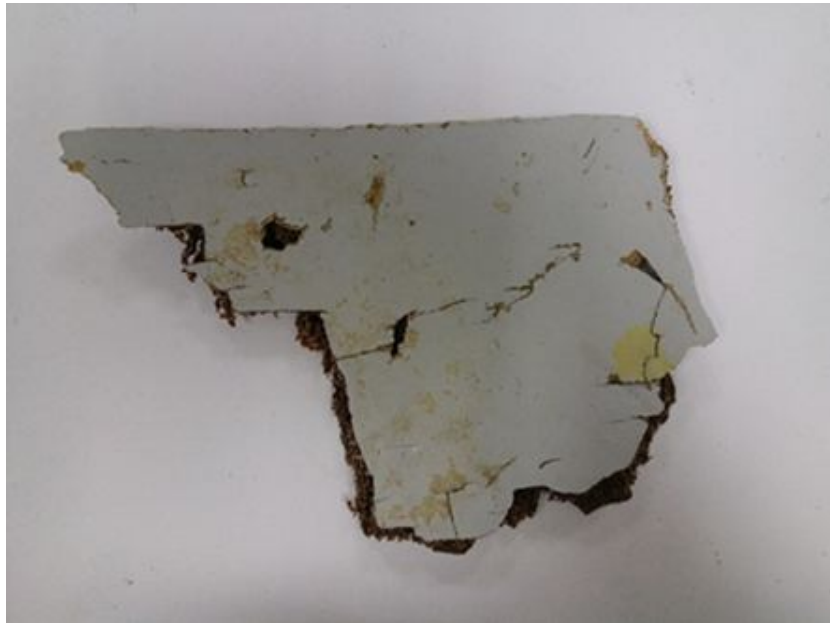
This item was recovered from Riake beach, Nosy Boraha Island, Madagascar in July 2016. It was identified as item 25 of the items recovered; refer to the *“Summary of Possible MH370 Debris Recovered”*.
